# DRAFT GAS EBULLITION EVALUATION

## REMEDIAL INVESTIGATION/FEASIBILITY STUDY, NEWTOWN CREEK

Anchor QEA, LLC

**November 2016**

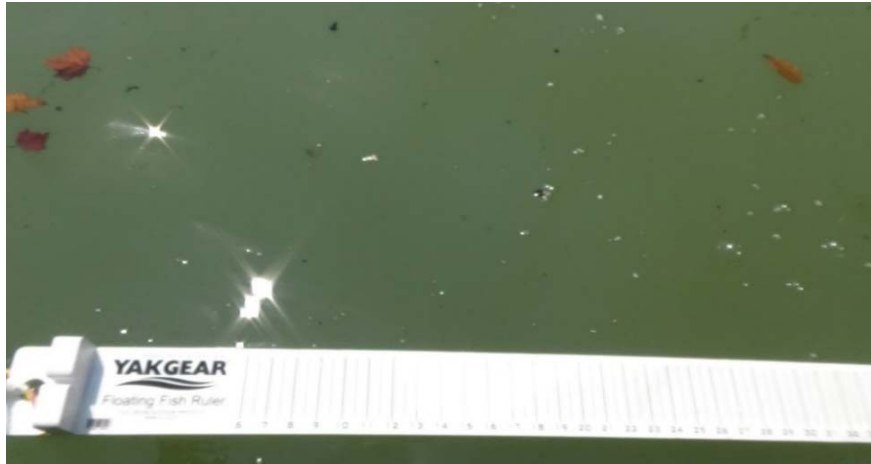
### English Kills Survey Area

Moderate to high bubble frequency (50 bubbles per minute)

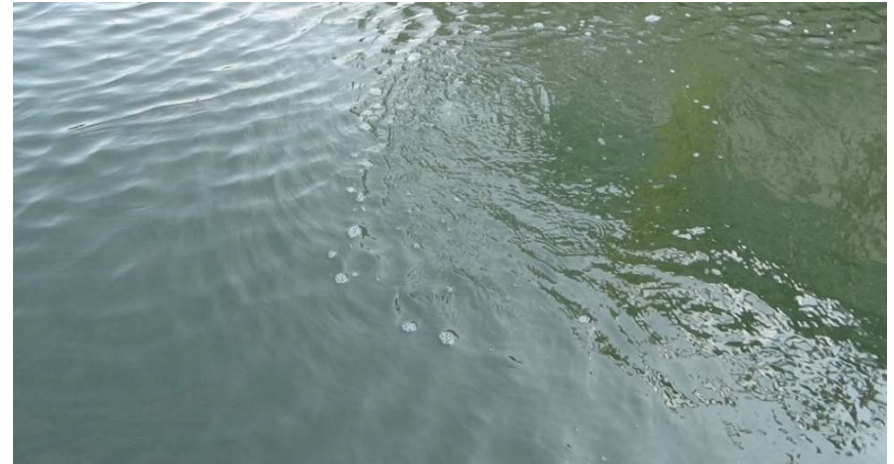
### English Kills Survey Area

Gas bubbles associated with aeration system operation

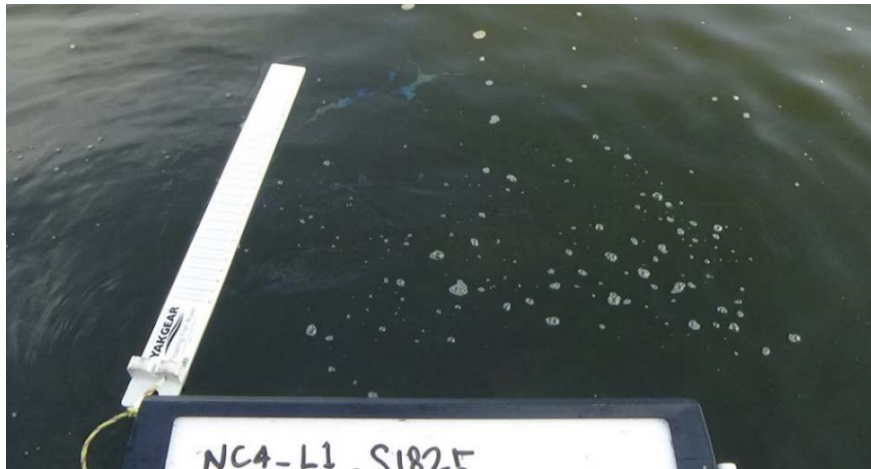
### CM 1.6 to 1.94 Survey Area

Moderate to high bubble frequency (199 bubbles per minute)

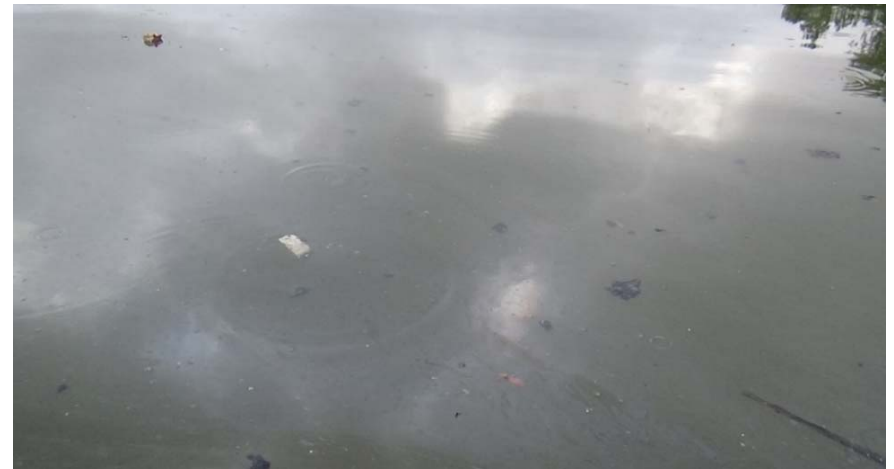
### Maspeth Creek Survey Area

Low to moderate bubble frequency (10 bubbles per minute)

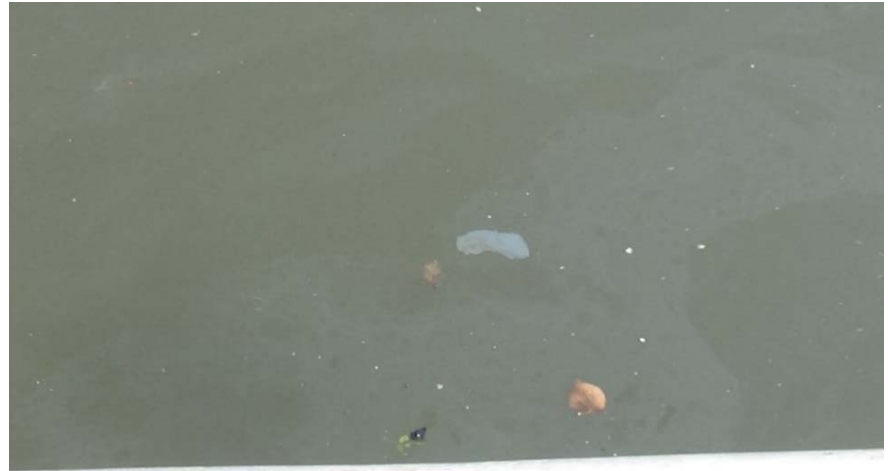
### English Kills Survey Area

Rainbow, non-brittle, small spots

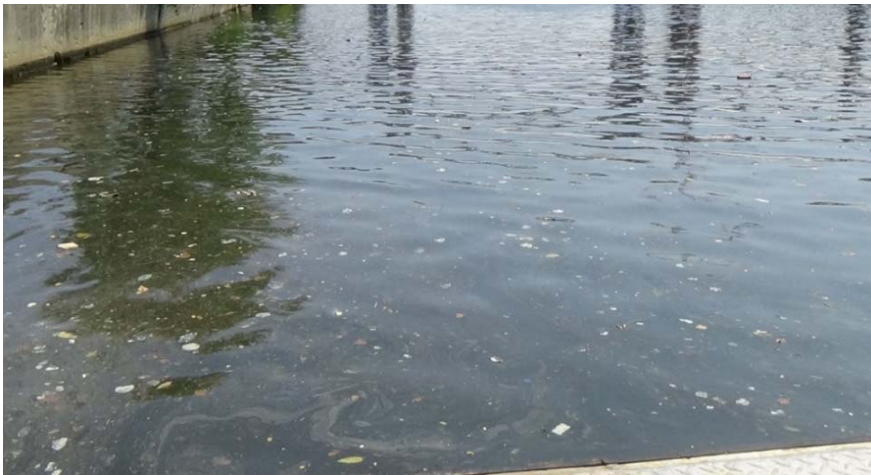
### CM 1.6 to 1.94 Survey Area

Silvery, non-brittle, contiguous

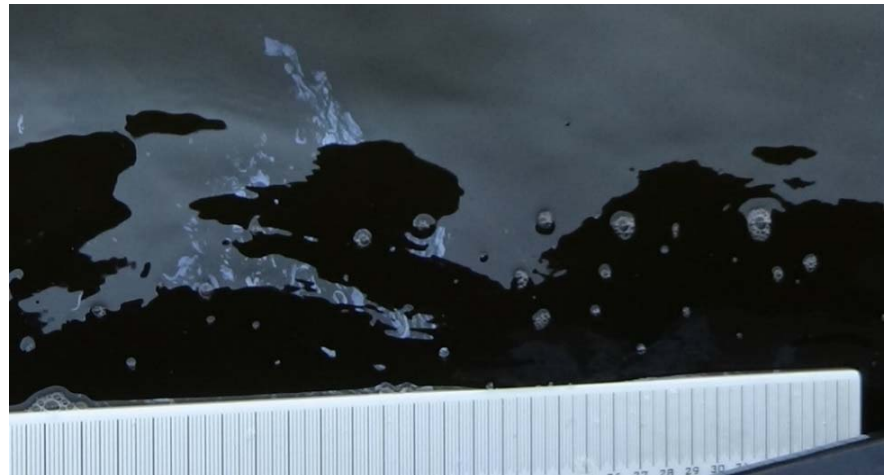
### Turning Basin Survey Area

Rainbow, brittle, spotty
